NISTIR 4425

Pulse-Echo Ultrasonic Evaluation of the
Integrity of Seams of Single-Ply Roofing
Membranes: Results of Field Investigations
and Recommendations

Prepared for:
Naval Facilities Engineering Command
Naval Civil Engineering Laboratory
Port Hueneme, CA 93043-5003

November 1990

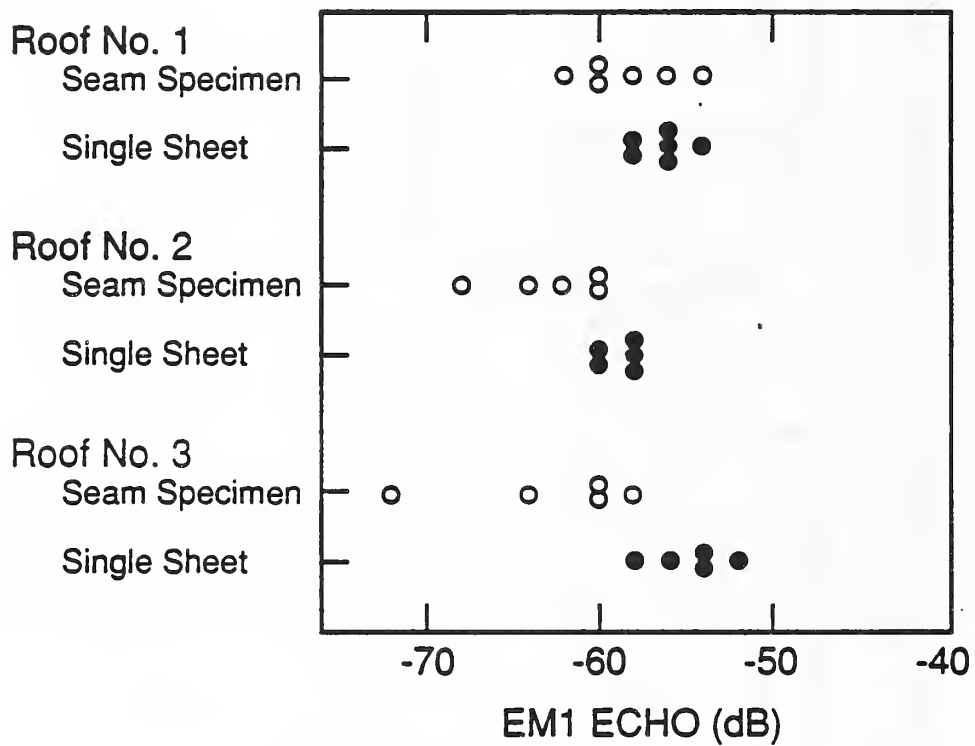
At first glance, the results in Figure 2 imply that the seam specimens contained some voids or some delaminations. In some

measurements, not only were the EM1 echoes of the seam specimens the same as those of the single sheet, but the intensity values were comparable to those recorded for voids in Phase 1 of the study [3]. For instance, in the laboratory, voids were shown to have EM1 echoes ranging from -46 to -62 dB [3]. However, delamination of the roof seam specimens in the Phase 2 study showed the adhesive layers to be visually free of voids or delaminations, as was found for roof no. 1 at the time of the initial field investigation.

Figure 2. Intensity of EM1 echoes measured for seam specimens and single sheets cut from roofs nos. 1-3. (A 5-MHz focusing transducer was used in the measurements.)

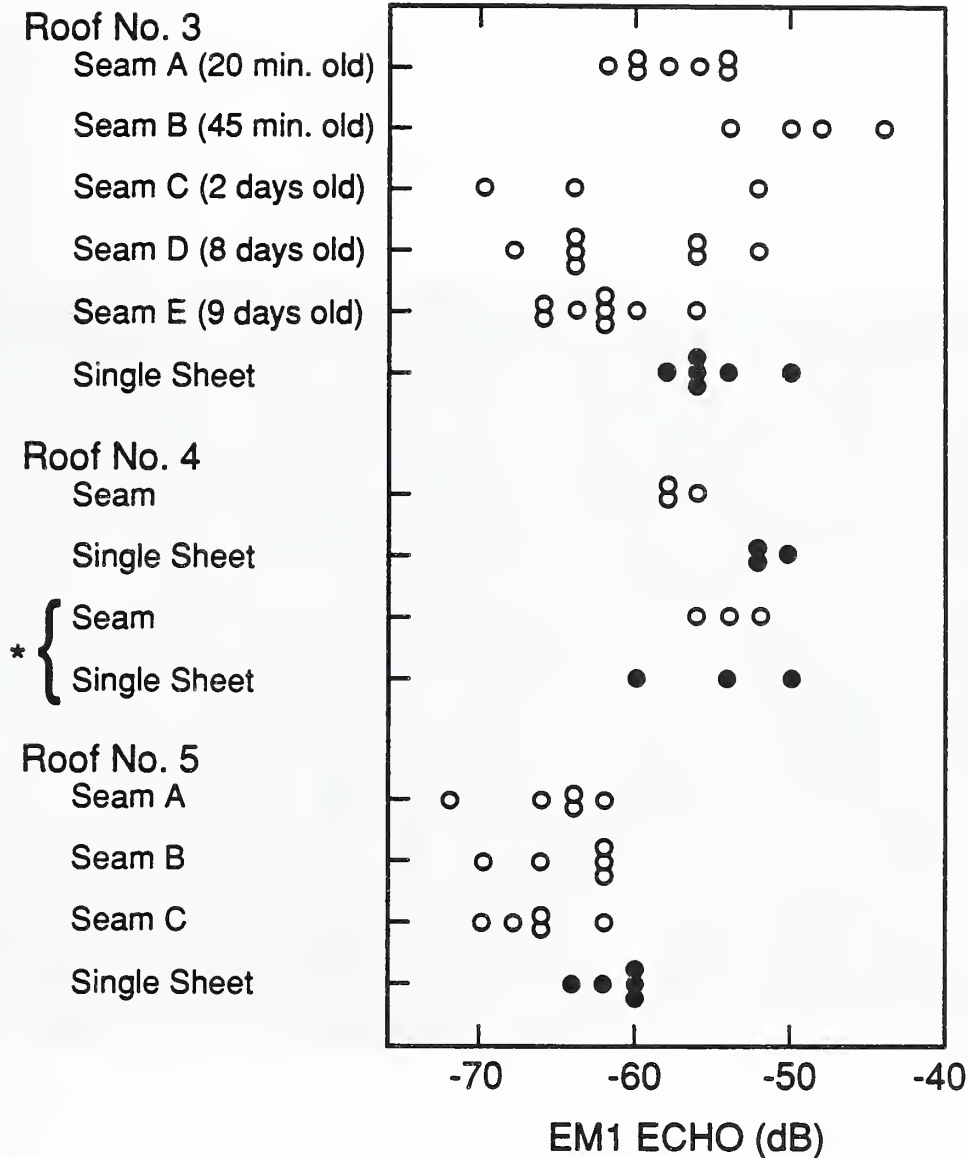
It should be noted, as a reminder, that the data given in Figure 3 represent locations where the field scanner was stationary to allow recording of the echo intensities. The recorded intensities were typical of those observed as the scanner was being pushed across the seam surfaces. It is difficult to believe that the seams would have performed satisfactorily for up to 4 years (e.g., roof no. 4), if they consisted mainly of voids and delaminations. Consequently, the results in Figure 3 were also considered to be generally "false positives."

Figure 3. Intensity of EM1 echoes measured in the field investigation for roof nos. 3-5. (Except where noted, a 5-MHz focusing transducer was used in the measurements.)

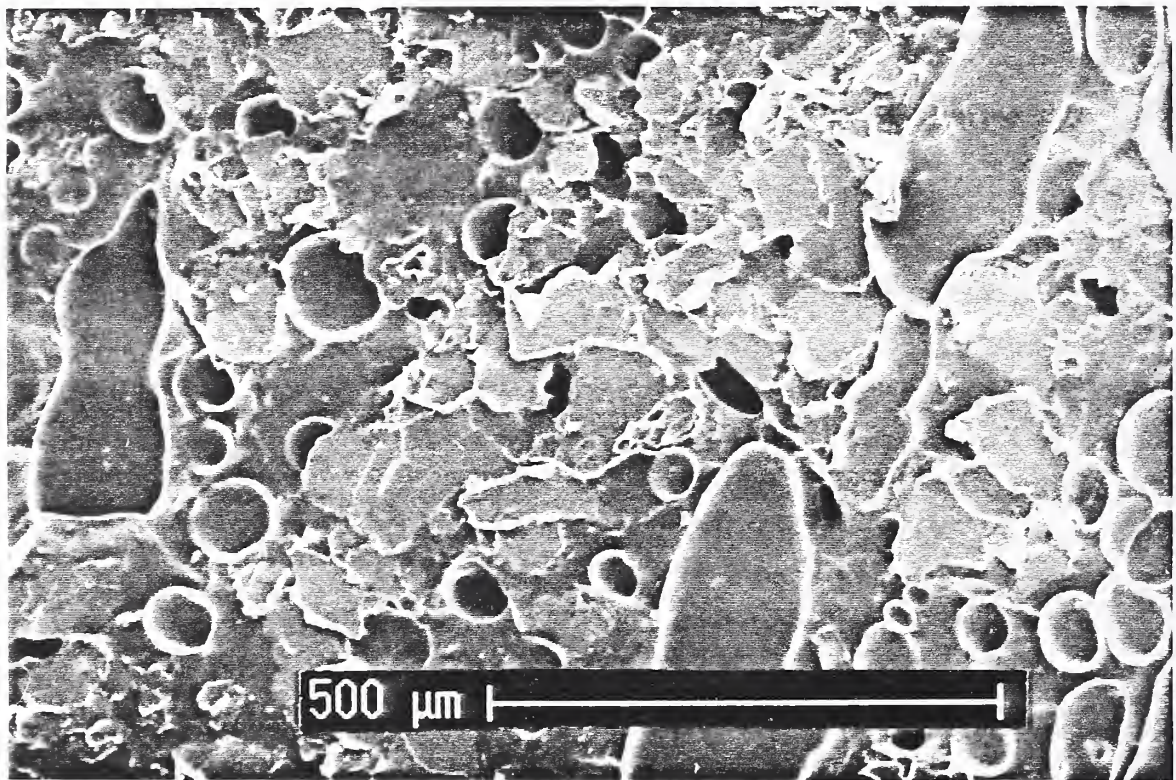
Sections of the delaminated strips were examined using scanning electron microscopy (SEM). A significant feature observed in the SEM analysis was the presence of micro-cavities (small bubbles) in the exposed surface of the adhesive layer. A typical micrograph illustrating the micro-cavities is shown in Figure 4. The diameters of the micro-cavities ranged from about 0.001 to 0.002 in. (0.03 to 0.05 mm). They are flaws in the adhesive layer which would be anticipated to cause lower-than-expected peel strengths as compared to specimens without micro-cavities present.

Figure 4. SEM photomicrograph of the ruptured surface of the adhesive layer in seam A of roof no. 3.

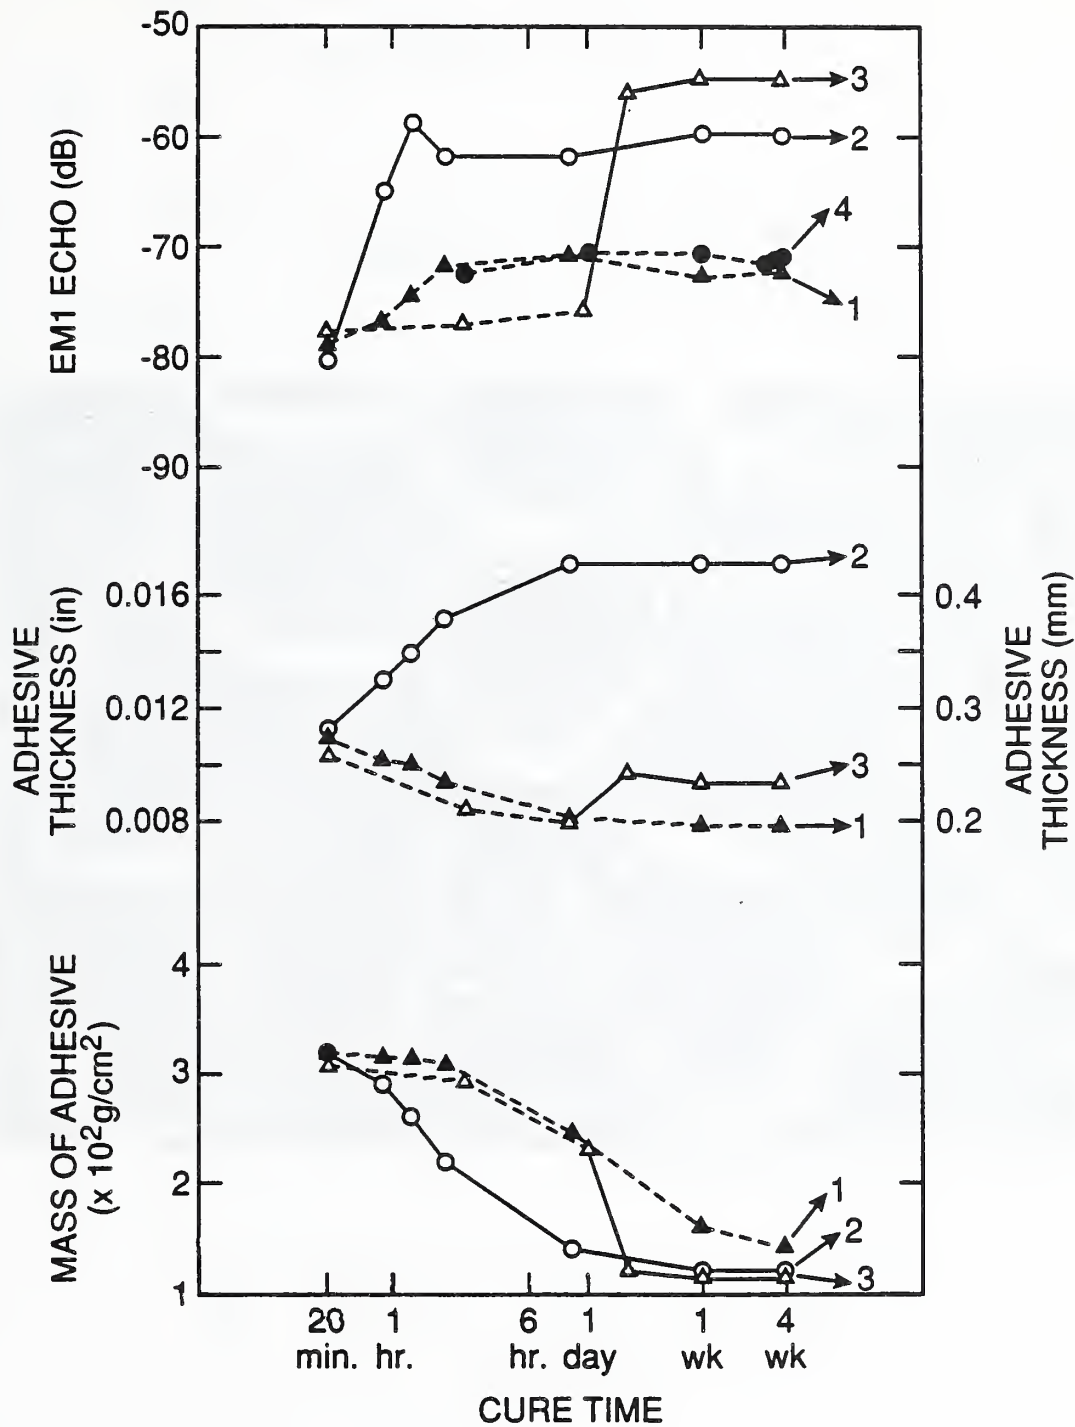
4.1.2 Results for the Specimens with Neoprene-Based Adhesive. Figure 5 gives the results of the echo intensity, adhesive thickness, and adhesive mass measurements made for the seam samples having neoprene-based adhesive. With the exception of cure condition no. 4, all measurements were first made after the specimens had cured for a minimum of 20 minutes at room temperature. Note that for each of the three variables, the initial measurements showed little variation. In the case of the pulse-echo measurements, the initial EM1 intensity of approximately

-80 dB was comparable to that obtained for a well-bonded specimen [3]. Over time, the specimen that was cured at room temperature (condition no. 1) continued to display an EM1 echo intensity typical of a well-bonded specimen, although a slight increase above the initial value was observed. In contrast, the specimens subjected to a heat cure within a day of seam formation (condition nos. 2 & 3) showed a significant jump in the intensity of the EM1 echo. The resultant value of -55 to -60 dB was typical of an echo from a void or delamination [3].

For the cases where adhesive mass was determined (cure condition nos. 1-3), the specimens showed a loss of mass (due to solvent loss) for at least the first week of cure (Figure 5). The loss was accelerated by the heat cure. The point to be made is that the specimens contained residual volatile solvent when they were subjected to heat-cure condition nos. 2 & 3, which produced the marked increase in intensity of the EM1 echo. It is evident in Figure 5 that the mass loss from the specimens was tending to a plateau as the cure time approached 4 weeks. It was assumed that the majority of the residual solvent had evaporated from the specimens over this time period. Thus, it was expected that a specimen subjected to a heat cure after most of the solvent evaporated would not show an increase in the intensity of the EM1 echo upon heating. Figure 5 includes the EM1 echo intensities for the specimen cured at condition no. 4. The EM1 echo was essentially unchanged by the heat-cure which was not applied until after a 3-week cure at room temperature.

Figure 5 also includes data on adhesive thickness for the cure condition nos. 1-3. When cured at room temperature, the adhesive thickness decreased as the adhesive lost mass. However, during the times of heat curing, the adhesive layers increased in thickness. This was most noticeable for cure condition no. 2, where the increase in thickness was about 60% of the original thickness. This percent increase could not be explained on the basis of normal thermal expansion of the rubber materials upon heating. It was not considered unreasonable to assume that the expansion was due to formation of micro-cavities in the adhesive layer.

Figure 5. Results of the laboratory experiment on elevated cure temperature for seam specimens fabricated with a neoprene-based adhesive. (The numbers adjacent to the curves indicate the cure conditions given in Table 3.)

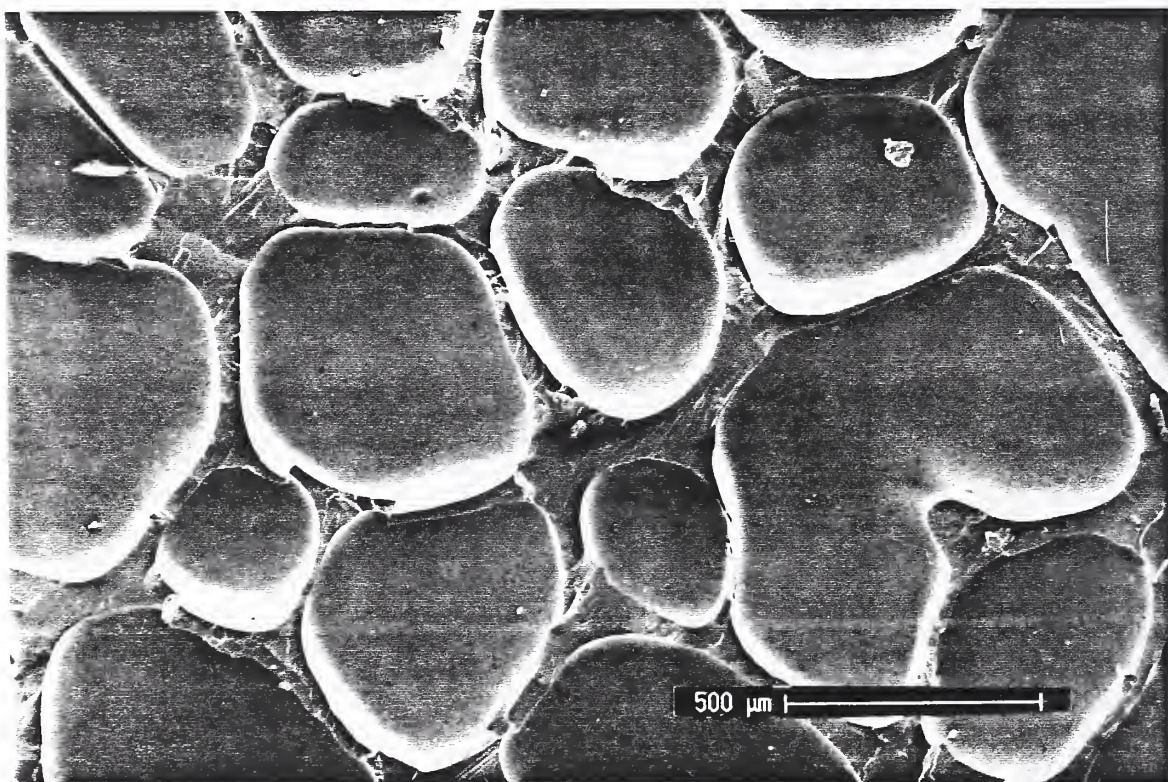
At the end of the experiment, the specimens were delaminated manually and visually inspected. In this case, microscopic analysis was not needed to see readily micro-cavities in the adhesive layers of the specimens that showed strong EM1 echoes after heat curing (cure condition nos. 2 & 3). In contrast, those specimens which displayed weak EM1 echoes showed no micro-cavities. Scanning electron microscopy was conducted, but micro-cavities were only observed in those specimens cured under condition nos. 2 & 3. Figure 6 shows a SEM photomicrograph of some micro-cavities.

Figure 6. SEM photomicrograph of the ruptured surface of the neoprene-based adhesive layer. Micro-cavities are apparent.

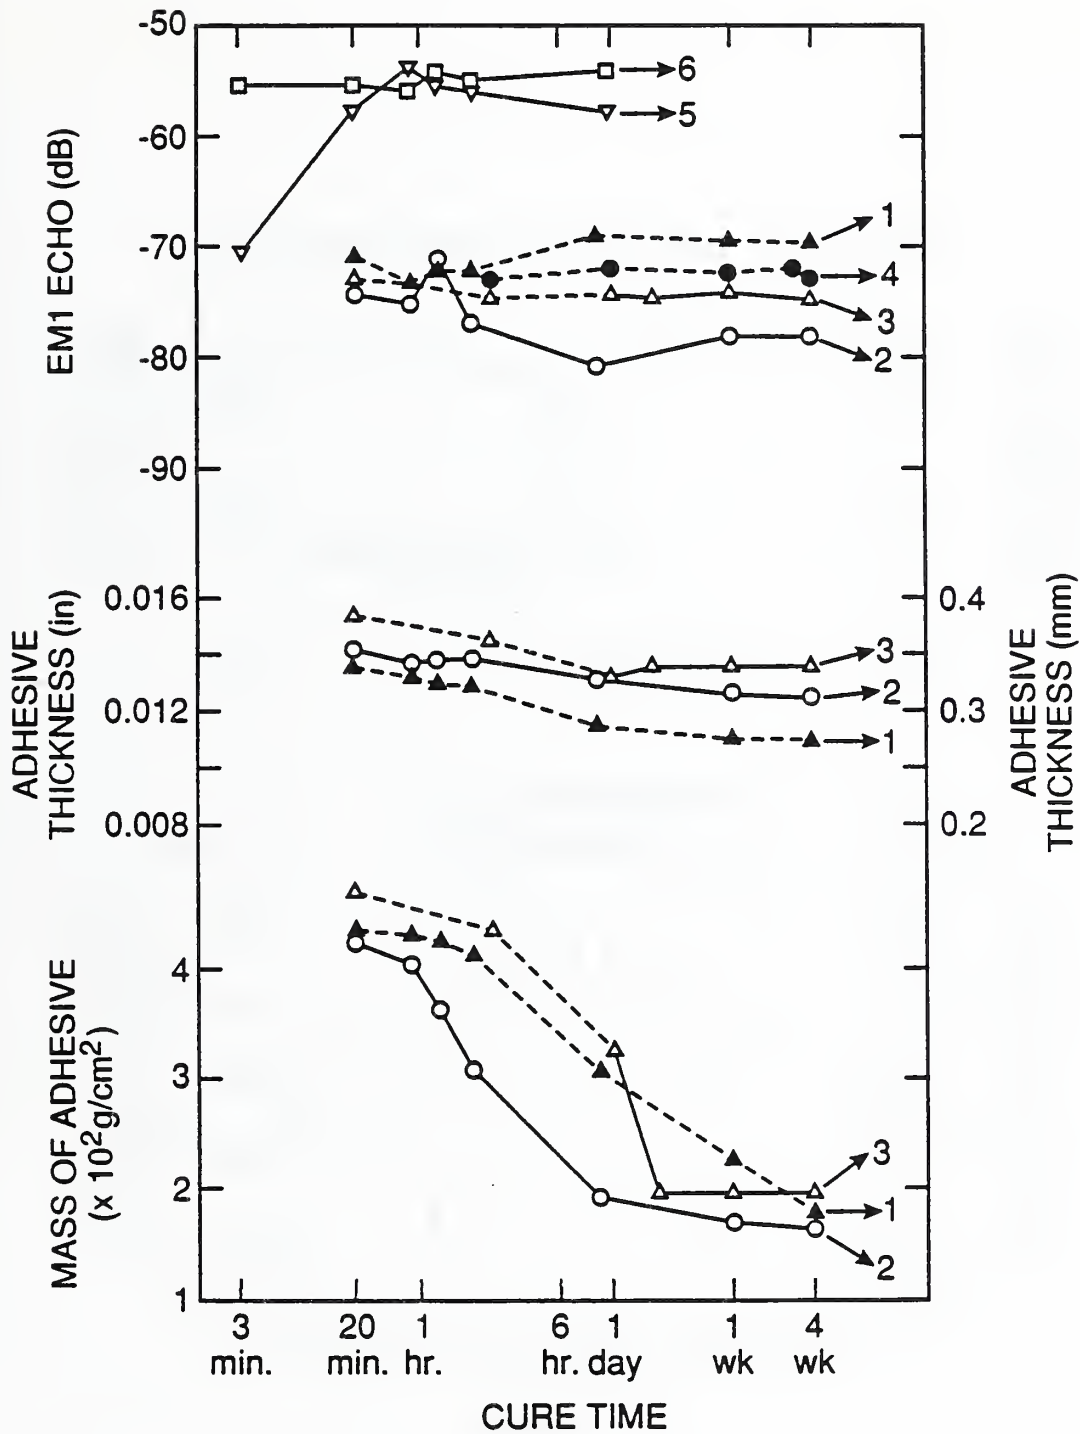
4.1.3 Results for the Specimens with Butyl-Based Adhesive. Figure 7 gives the results of the echo intensity, adhesive thickness, and adhesive mass measurements made for the seam samples having butyl-based adhesive. The results for the EM1 echo intensity measurements for cure condition nos. 1-4 may be compared with those for the neoprene-based adhesive specimens given in Figure 5. Unlike the results for neoprene-based adhesives, the heat-cure (condition nos. 2 & 3) of the butyl-based adhesives produced no significant changes in the measured properties of the specimens. It was found for the butyl-based adhesives that no sharp increases in the intensity of the EM1 echo were observed after the heat curing.

The implication of these pulse echo measurements was that micro-cavities were not generated in the adhesive layers. This was found even though the specimens contained residual solvent, as demonstrated by the adhesive mass loss observed over time (Figure 7). Also, consistent with the lack of micro-cavity formation was the observation that no significant increases in the adhesive layer thickness were observed when the specimens were heat-cured. At the end of the 4-week cure period, delamination followed by visual and microscopic examination of the exposed adhesive layers showed no evidence of micro-cavities.

The results of the pulse echo measurements for the cure condition nos. 5 & 6 are given in Figure 7 along with the data previously discussed. It was found that, when the adhesive was applied to the rubber at room temperature, the immediate determination of the

intensity of the EM1 echo was akin to that of a well-bonded specimen. However, after 20 minutes of heat-cure, the EM1 intensity displayed a sharp increase and was typical of a void in the adhesive layer. When the adhesive was applied to heated rubber (cure condition no. 6), the intensity of the EM1 echo measured immediately upon seam formation was typical of that produced by a void in the adhesive layer. The observations for cure conditions 5 & 6 were consistent with the formation of micro-cavities due to expansion of residual solvent in the adhesive layer. SEM analyses of the delaminated specimens at the end of the cure period showed micro-cavities to be present.

Figure 7. Results of the laboratory experiment on elevated cure temperature for seam specimens fabricated with a butyl-based adhesive. (The numbers adjacent to the curves indicate the cure conditions given in Table 3.)
